# Manhole Inspection Summary

Manhole # S21K\_\_038MH

Insp Date: **9/26/07 10:32 AM**

**Location** Address: **1910 PRATT ST** Cross Street: **PAYSON-MONROE**

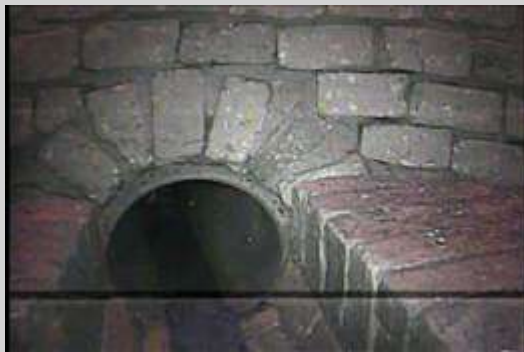
12 O'Clock Outflow

8 in. Circular Gravity Sewer  
Pipe Out @ 12 O'Clock

Pipe Height: **8.4** (in.) Rod and Bar (Angled)  
Pipe Material: **Clay** ☐ Pipe Lined  
Invert Depth: **10.33** (ft.) Flow Characteristics: **Slow**  
Deposits: ☒ None ☐ Mud ☐ Sludge ☐ **Debris** ☐ Grease  
Silt Depth: (in.) Deposits Extent:  
Infiltration: **None** Pipe Seal Cond: **Sound**
